A Geographical Study of Flooding in Laymyethna Township, Ayeyarwady Region

Abstract

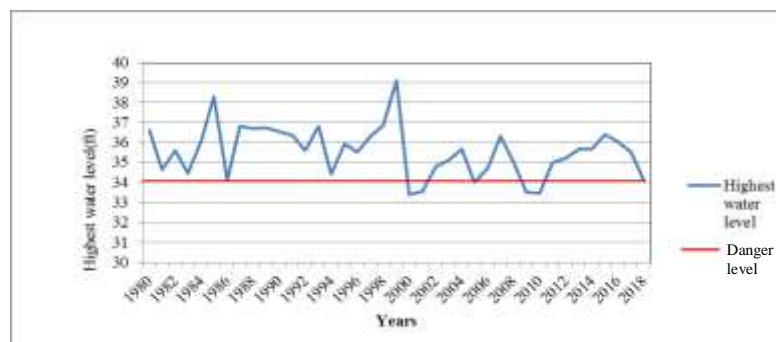
Figure (2) shows the water level of Ngawun River from 1980 to 2018 in Laymyethna. In the study area, danger level of Ngawun River is 34 feet (10.36 m) above the sea level. During the 39 years period, four years, 2000, 2001, 2009, and 2010, were free from flooding. The remaining 35 years reached danger level and above danger level. Therefore, Laymyethna Township suffered the flooding in most of the years.

Figure (2) Water level of Ngawun Riner at Laymyethna from 1980 to 2018.

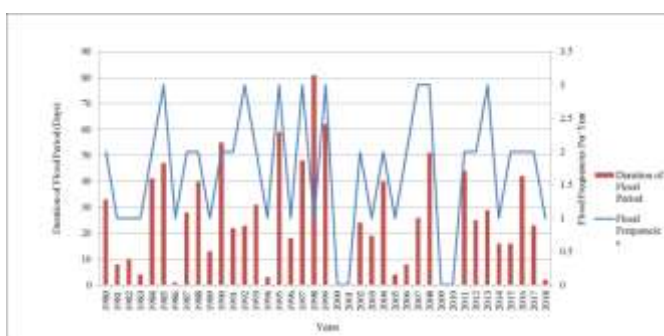
Figure (3) presents the duration of flood period per year and frequency of flood during 39 years from 1980 to 2018. According to the figure, water level was the highest in 1999 with 39.1 ft (11.917m). In 1999, frequency of flooding was 3 times and duration of flooding period was 61 days. The second highest of water level was 38.3 ft (11.67 m) in 1985. The water level was lowest 33.4 ft (10.18 m) in 2000. Flooding frequency is not more than 3 times per year, especially in July, August, and September. In these months, the amount of rainfall is the highest in the study area.

Figure (3) Duration of Flood Period and flood frequencies per year of Ngawun River (1980-2018). Source: Irrigation Department, Hinthada

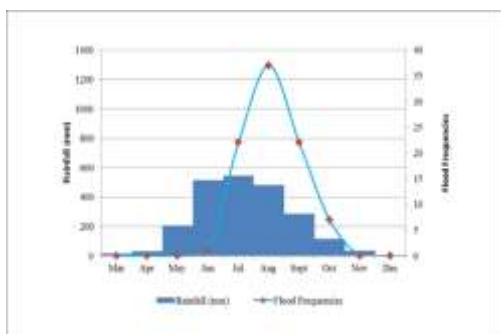
The relation of flood frequencies of Ngawun River and average monthly rainfall is presented in figure (4). In this figure, the frequency was the highest in August, the second highest in July and September. July, and August were the months in which there was the highest rainfall, but the rainfall was low in September. It shows that the flooding is not only related to local rainfall but also up-flow of water and storms. Therefore, local rainfall is assumed constant in this study.

Figure (4) Average Monthly Rainfall (1991- 2018) and flood frequencies of Ngawun River (1980-2018).

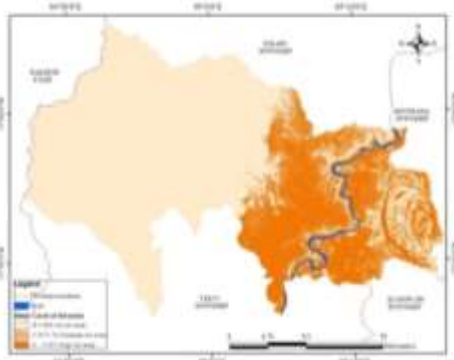
Water level of river is one of the important factors of flooding. Water level rises in monsoon period, especially June, July, August and September due to rainfall and storms. In addition, up-flow of river causes to raise the water level in the river. From 1980 to 2018, the highest water level of Ngawun River reached 39.1 ft. (11.9172 m) above sea level during 39-year period. The lowest level reached 33.4 ft. (10.18 m). Water levels are classified into 3 classes: -4 - 11.917 (high risk) due to the highest water level in 39 years, 11.9171-15 (moderate risk) due to flash flood by heavy local rainfall and storm, 15.1-625 (not risk). Weight of the parameter is 25 percentages, calculated by rank sum method. Water level of Ngawun River is presented in figure (5).

Figure (5) Water Level of Ngawun River at Laymyethna Gauge (6 AM) from 1980 to 2018
Source: Irrigation Department, Laymyethna and SRTM DEM (30 metres) resolution

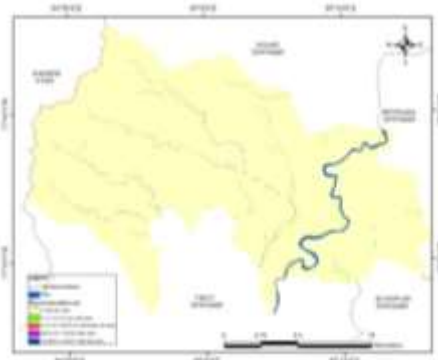
Second important parameter is flow accumulation of water in the study area. Flow accumulation is derived from DEM. It is grouped into five types: 0 (not risk), 0.1-41101.67

(low risk), 41101.671-82203.33 (moderate risk), 82203.331-123305 (high risk). Weight is 21 percentages. Figure (6) shows the flow accumulation of water in the study area.

Figure (6) Flow accumulation of Water the Study Area
Source: SRTM DEM (30 metres) resolution

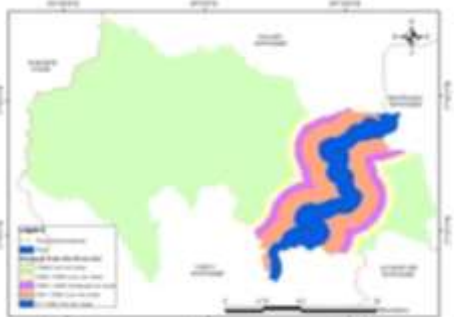
Distance from the river is one of the important factors of flooding. It is divided into 5-classes depending on the nearness to the river: 0.1-1000 (high risk), 1000.1-3000 (risk), 3000.1-4000 (moderate risk), 4000.1-5000 (low risk), >5000 (not risk). The weighted percentage is 18 in this analysis. Distance from the river are shown in figure (7).

Figure (7) Distances from River
Source: UTM Topo Map (2005)

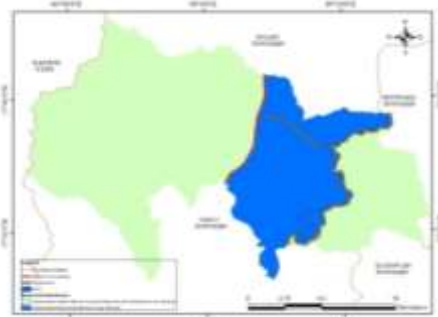
Road and embankment is the barrier of flooding, it is important in flooding. In the study area, Pathein -Monywa Road is located in the western part of the River. Along the eastern part of Ngawun River, embankment was built to protect the flood water of the River, which has a length of 19 miles and 7 furlongs was established between 1869-1884. (Imperial Gazetteer of India, 1881) The study area is grouped into two: area between western Rakhine Yoma and Pathein_Monywa Road, and area within embankment (not risk), area between road and embankment (high risk). Weight percentage is 14. Figure (8) presents the road and embankment of the study area.

Figure (8) Road and Embankment in the Study area
Source: UTM Topo Map (2005)

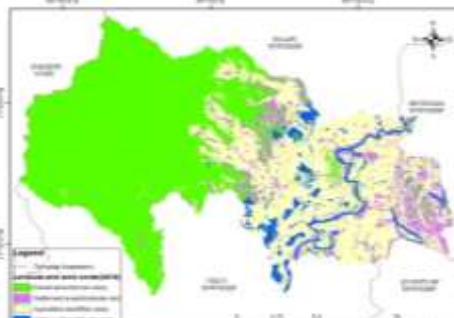
The fifth important parameter is land use and land cover in this analysis. Image is classified into four types by maximum likelihood classification. They are forest land, settlement area, agriculture area, and water bodies. In this study, forest land is assigned not risk because of forest absorbed water and fixed the soil, settlement area assigned moderate risk due to human impact, agriculture area assigned risk because of plowing for agriculture, and water bodies assigned high risk because of low elevation. Weighted percentage is 11. Land use and land cover of the study area are presented in figure (9).

Figure (9) Landuse and land Cover of the Study area
Source: Satellite Image 2018 (30 m resolution) 133,048

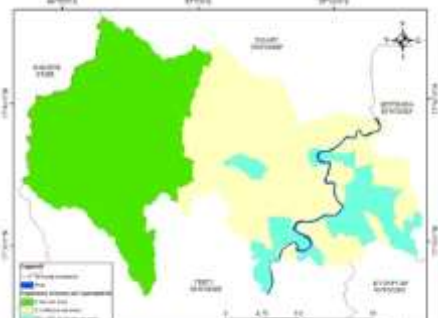
Population density is important in flooding. It is classified into three classes: 0 (not risk), 0.1-248 (low risk), 248.1-960 (medium risk) due to high density. The weighted percentage is 7. Figure (10) shows the population density of Laymyethna Township in 2018.

Figure (10) Population Density of the Study area (2018)
Source: General Administrative Department, Laymyethna

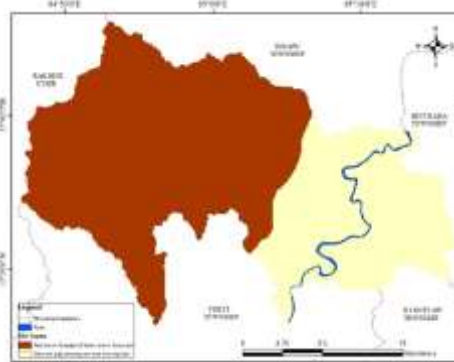
Soil is important in flooding, because of the infiltration intensity of water. Solis map shown in figure (11) is acquired from Ministry of Agriculture and Irrigation (2004) in which the soil types are characterized as follows.

Among these 4 types, red brown forest soil and yellow brown forest soil have been found in the western part of the Township. The texture is Clay loam, Sity loam, and Sandy clay. Gley and gley Swampy Soils and Swampy Soil are found over the flood plain of the Ngawun River. The texture of Gley and gley swampy soils and swampy soils is Clay and the depth is thick. Clay and thickness favour low infiltration rate. Low infiltration causes the flooding in the study area. In the analysis, soil types are grouped into two: red brown forest soil and yellow brown forest soil (no risk), and Gley and gley swampy soil and swampy soil (high risk). Weighted percentage is 4% in this analysis.

Figure (11) Soil Types of the Study area.
Source: Ministry of Agriculture and Irrigation (2004)

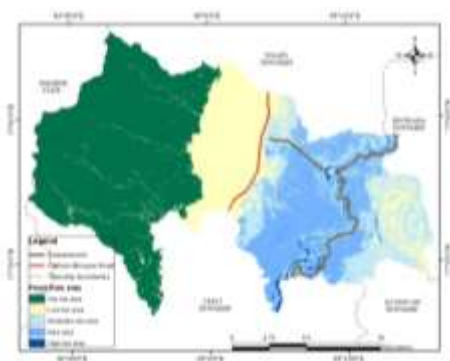
Seven parameters mentioned above are used to search for flood risk area by using weighted overlay using raster calculator. Figure (12) and table (2) show the result of this analysis. Flood Risk Index shows 100 to 461, high risk area (0.5%), risk area (19.3%), moderate risk area (14.8%), low risk area (20.4%) and not risk area (45%) of the study area. In high risk area, Mezali, Yinze, Thaungbok, Kattu village tracts are found. Hledaukwun, Hlawkata, Daunggyi, Chaukse, Mogok, Kyiboukkone, Bithalun, Bokchaung, Shamywa, Lethama(Myanmar), Lethama (Kayin), Thonzet, Thakutchaung, Nyaungbinwe, Hteingu village tracts and urban area lie within the risk area. Moderate risk area includes 13 Village Tracts such as Kungyongon, Kadetkon, Thenugon, Chingon, Aingthabyu, Sayegyin, Lahagyi, Sayegyin, Gyogyakwin, Kode, Yenauk, and Hteindawgyi village tracts. Theingon, Wayongyaing, Peinin, Kamauksu, Wadawkwin, Bebyagon, Pandawgyi, Wetkon, Kwingyi, Kanyindaing, Chinle are found in low risk area. In the western Rakhine Yoma, forest area is of no risk in Laymyethna Township. Figure (13) presents the flood risk area and village tracts of the study area.

Figure (12) Flood Risk Map of the Study Area
Source: Result of the Analysis

The result is validated with the village tracts of flooded monsoon paddy from 2015 to 2018. It shows that the risk area coincides the village tracts of flooding paddy field and school. Therefore, water level of Ngawun River, flow accumulation of water, distance from the river, Road and Embankment, land use and land cover, population density and soil are the chief causes of flooding in the study area.

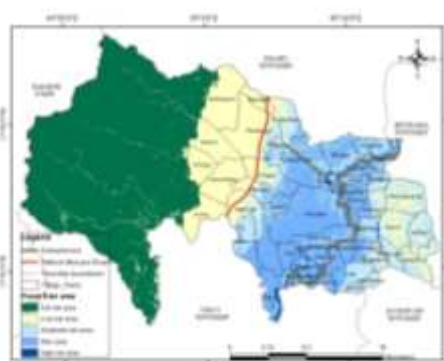
Figure. (13) Flood Risk Area and Village Tracts of the Study Area
Source: Result of the Analysis and Land Records Department, Laymyethna
